ANNUAL REPORT FOR 2010

Bailey Branch Site D Mitigation Site
Madison County
TIP No. R-2518A

Prepared By:
Natural Environment Unit & Roadside Environmental Unit
North Carolina Department of Transportation
December 2010

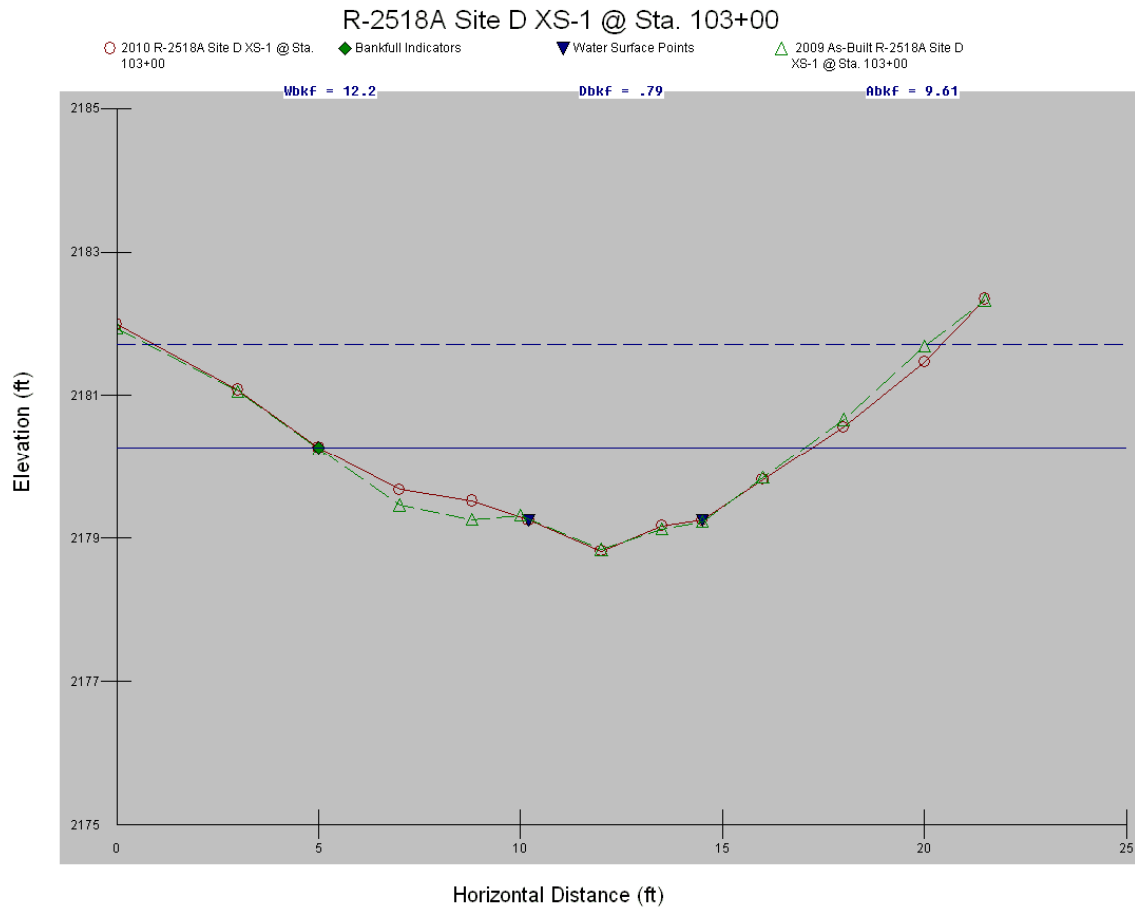
Site D: Cross-Section #1 (Riffle) Abbreviated Morphological Summary					
	2010	2011	2012	2013	2014
Bankfull Cross Sectional Area (ft ²)	9.61				
Maximum Bankfull Depth (ft)	1.45				
Width of the Floodprone Area (ft)	19.54				
Bankfull Mean Depth (ft)	0.79				
Width/Depth Ratio	15.47				
Entrenchment Ratio	1.6				
Bankfull Width (ft)	12.22

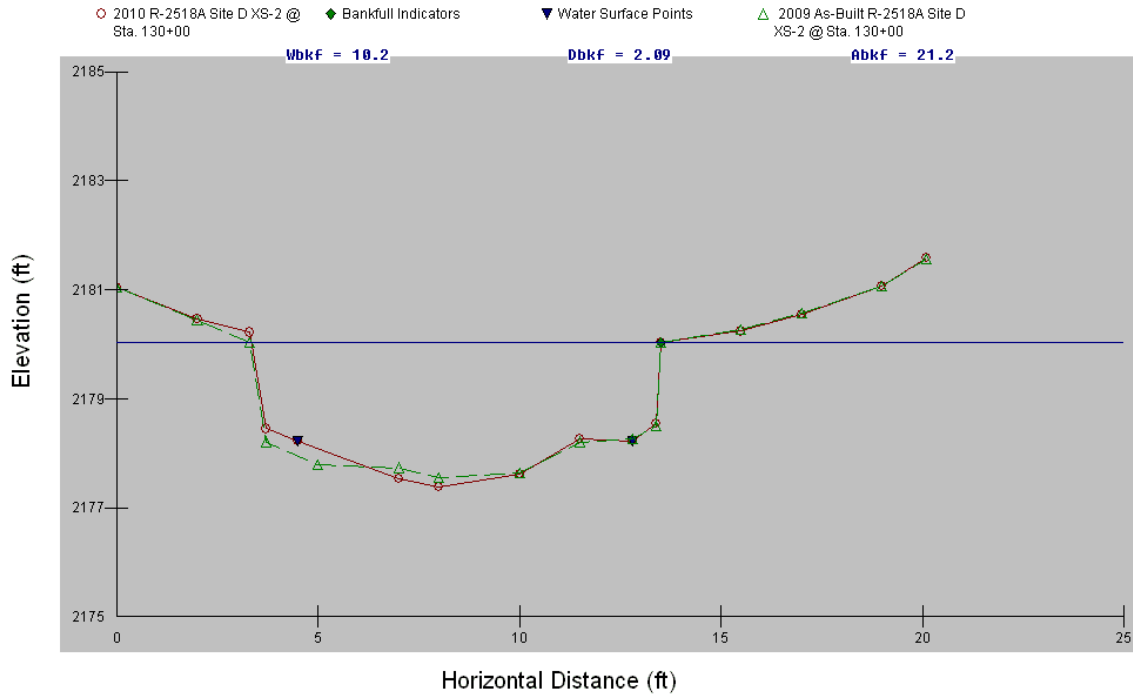
R-2518A Site D XS-2 @ Sta. 130+00

Site D: Cross-Section #2 (Pool) Abbreviated Morphological Summary					
	2010	2011	2012	2013	2014
Bankfull Cross Sectional Area (ft ²)	21.23				
Maximum Bankfull Depth (ft)	2.65				
Bankfull Mean Depth (ft)	2.09				
Bankfull Width (ft)	10.16
